2010/2011 Annual Inspection Report

SEDIMENT TRAPPING AT THE JAWS PROJECT (TV-15)

State Project Number TV-15 Priority Project List 9

April 5, 2011 St. Mary Parish

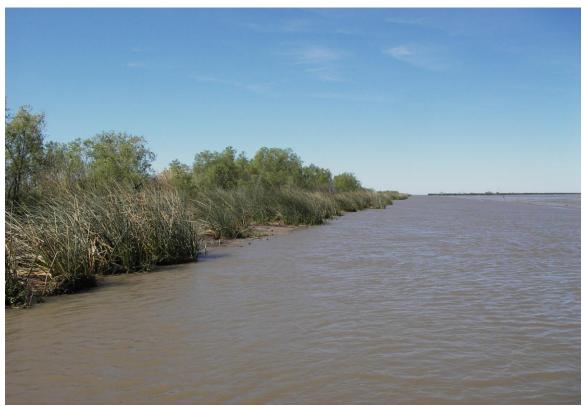
Photo No. 1, typical terrace

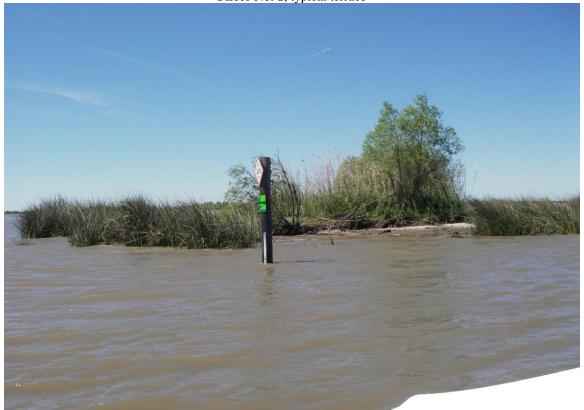
Photo No. 2, typical terrace and warning sign

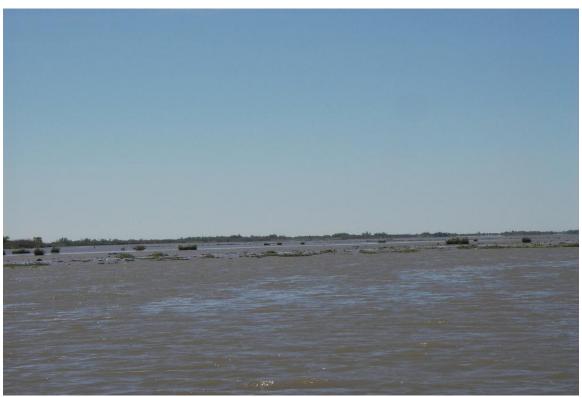
Photo No. 3, emergent vegetation between terraces

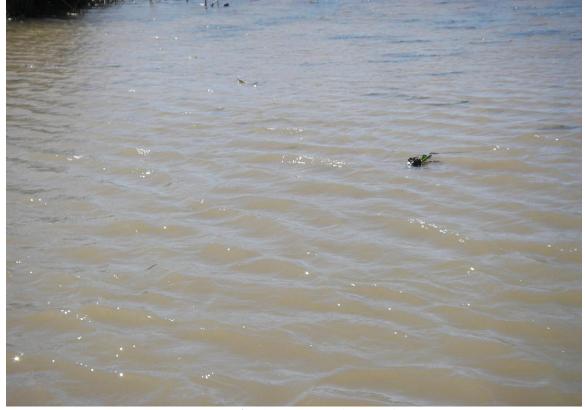
Photo No. 4, submerged aquatic vegetation
